Making practical decisions when repairing machined holes in fiberglass boats

Technical Staff Report

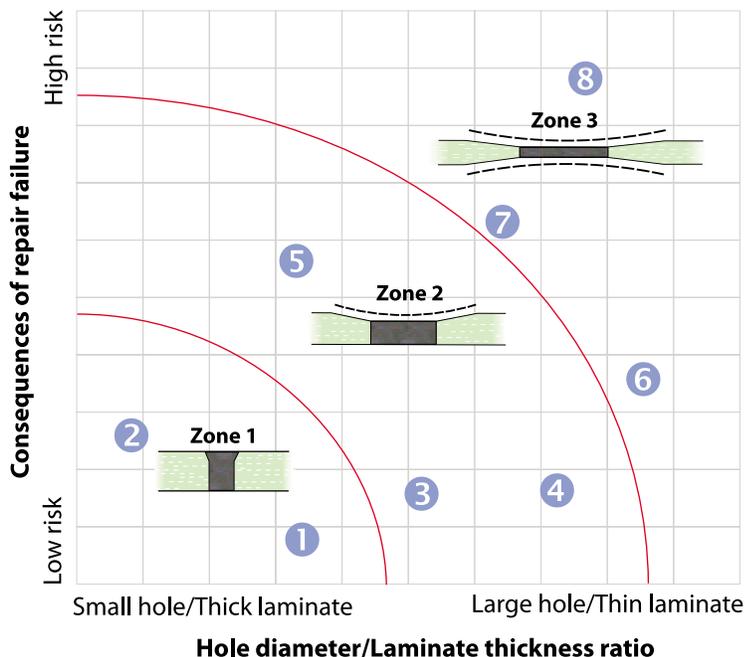
Use this chart by finding a vertical line on the graph that balances both hole diameter and laminate thickness. Determine the consequences of repair failure and find a horizontal line that represents the level of risk. Where the lines intersect will determine the importance of repair strength. Repairs that are in the upper right corner need to be done very conservatively, and repairs that are in the lower left corner can place a lower emphasis on strength. The chart also demonstrates the relationship between thickness and hole diameter. A hole with a large diameter is more highly stressed in a thin laminate than in a thick laminate.

Few repairs are identical, and many variables can influence the appropriate repair strategy. In a best-case scenario, a repair can be very simple: force thickened epoxy to fill the hole, scrape it flush, and allow the epoxy to cure. At the other extreme, a repair of structural fiberglass might involve grinding both sides, bonding in reinforcing fibers, sanding the entire repair flush, gelcoating, and finishing to a high gloss. The first job could take ten minutes and the latter many hours, if not days. There is no tidy repair sequence for all hole repairs. First, you need to think carefully about each hole. The chart at left and this discussion of different types of repair strategies from the simplest to the most complex can help you decide the best repair strategy for most hole repairs.

The following two examples can be repaired with thickened epoxy because their characteristics put them in the lower left-hand corner of the chart. They require no additional fiberglass reinforcement.

This repair would meet the criteria in the lower right quadrant of the chart. It is a relatively large hole, and liners are generally thinner laminates even though they often provide a structural component to the hull. While the consequences of a complete repair failure would be quite low, it would still be a good idea to repair this hole by grinding a 12:1 bevel around the circumference of the hole and laminating in a layered fiberglass patch, as described in detail in our manuals.

The chart would place this repair in the upper right quadrant due to the hole's location—a hole below the waterline certainly raises the consequences if it fails—yet, because this is a machined hole and not a puncture or impact hole, the repair should be easy to accomplish. The first step is to sand the inside of the hole to expose fresh laminate. Next, pour some mixed epoxy into a 2" diameter cup to form a "puck" when cured that is about 1/8" to 3/16" thick. Sand the edge of the puck and both face surfaces, and then dry fit the puck in the hole so that it is centered with regard to the thickness of the laminate. You can then bond the puck in by brushing a thickened mixture of epoxy and 406 Colloidal Silica on the inside of the hole and the edges of the puck. If the puck fits loosely and doesn't stay where placed, use duct tape to hold it in place until the epoxy cures.

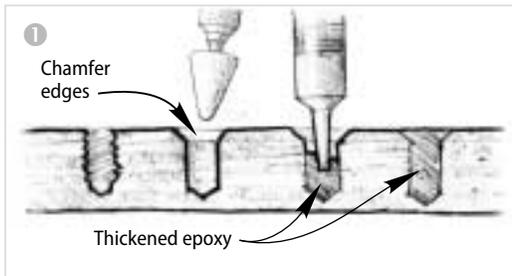
In thicker laminates, removing the screw may result in a blind hole, a hole that does not go completely through the laminate. In this case, use a syringe to fill from the bottom of the blind hole. If the hole is deeper than the length of the syringe nozzle, use a soda straw to extend the length of the nozzle. Trying to force thickened epoxy into a blind hole with a putty knife always leaves an air bubble at the bottom of the hole. Filling from the bottom forces all air out of the hole.

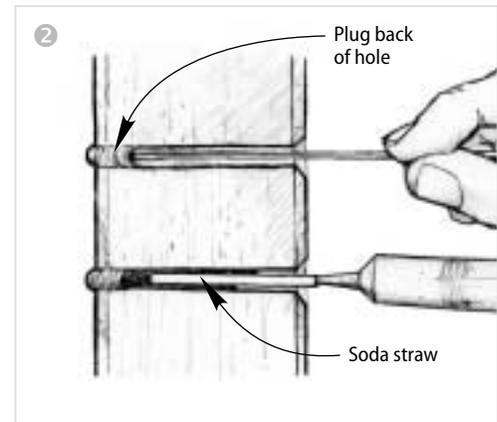
Prepare this hole by reaming and countersinking as described in Example 1. Because there is no access to the inside of the transom, you should install a plug in the hole to keep the epoxy from running through while it is curing. You can make a plug by saturating some type of absorbent material with epoxy and forcing the wet plug to the back of the hole. Cotton balls, foam ear plugs, foam rubber from a pillow, paper towel, Kleenex, or any other absorbent material will work. Once the plug is in place and at least partially cured, finish the repair.

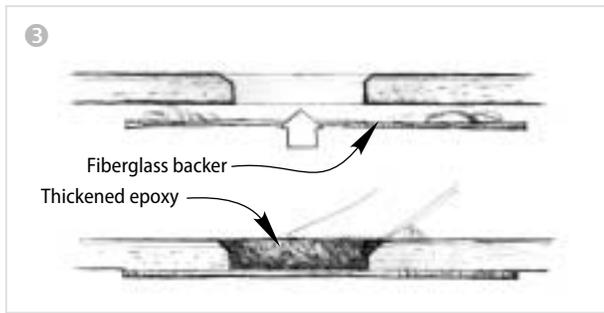
Sand the inside surface of the hole to expose clean laminate. Also sand a 3" diameter area around the hole, on the underside of the laminate. Chamfer the top lip (the gelcoated side) of the hole, about 1/4" back, with a countersink bit or a rotary abrasive tool.

Wet out these areas by applying a coat of unthickened (neat) epoxy. Then wet out a piece of fiberglass cloth 2 1/2"-3" in diameter and apply it to the sanded area on the inside of the hatch. Allow it to cure to a soft gel. Then fill the hole flush with the surface, using epoxy thickened with a WEST SYSTEM® high-density filler.

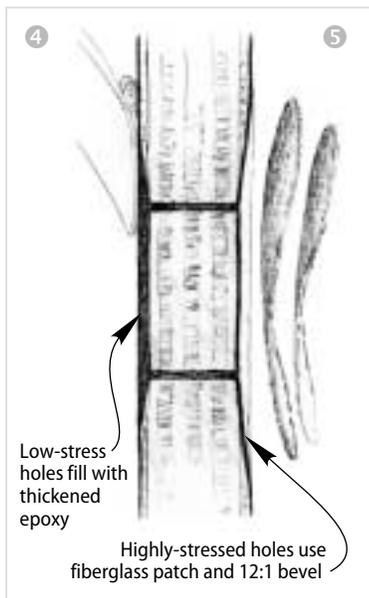
Example 5 A 1" diameter hole drilled near the hull bottom through a structural laminated fiberglass bulkhead with a 3/4" plywood core. Bilge water should not be allowed to flow through the hole.

Since the repair is to a structural component and needs to be watertight, the consequences of failure are higher than the previous examples. While it is likely that simply filling this hole will provide enough strength, overlaying the plug with fiberglass will provide more strength and better sealing. What is needed here is to bond in a wood plug that is a bit thinner than the plywood core so that once the epoxy cures you can laminate over it and maintain the original bulkhead thickness.

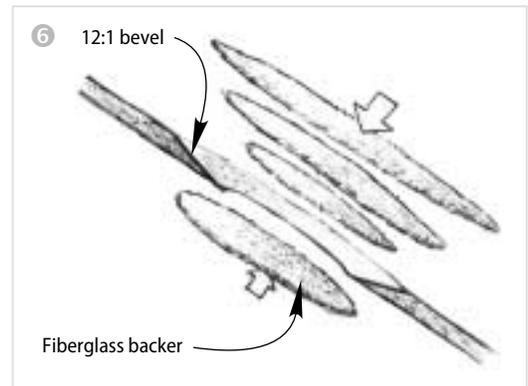
A backer plate may be necessary to keep the layers in the patch from pushing through the hole. A simple way to make a backer is to wet out a piece of lightweight fiberglass on a sheet

of polyethylene plastic and allow it to cure. You can then easily cut this single thickness of glass with scissors to a size larger than the hole and bend it to fit through the hole. Bond this backer plate to the inner surface of the laminate with G/5 Five-Minute Adhesive. You can then lay the fiberglass patch in place without pushing through, squeegee it down and allow it to cure. Then prepare this surface for fairing and finishing.

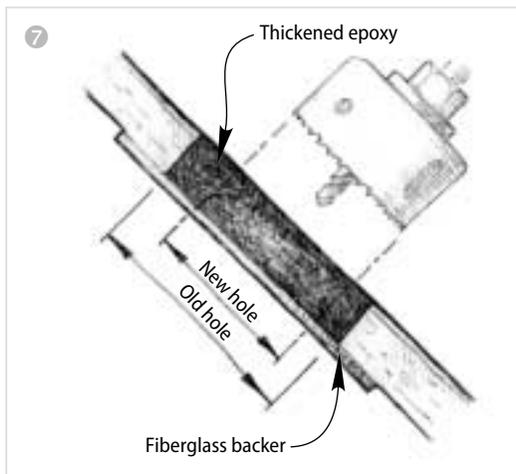
In situations like this, where the difference in hole diameter between the old and new hole is 1/2" or less and the screw pattern for the new thru-hull will be in the original laminate, you can get away with adding minimal reinforcement from one side. To do this, sand the inside of the hole to expose clean laminate, sand the laminate on the backside (4"-5" diameter area centered over the original hole), and apply the reinforcement. The reinforcement could be a layer or two of fiberglass cloth with epoxy, a thin layer of cured fiberglass laminate like G-10, or a 1/4" thick piece of plywood sealed with epoxy.

When the epoxy used in your reinforcement has gelled, use epoxy thickened with 403, 404, or 406 filler to fill the hole. After the thickened epoxy has cured, use a hole saw to cut the new hole. Dry fit the new thru-hull fitting, trimming the fiberglass as needed. Use the fitting as a template for locating the new screw holes. Be sure to seal all exposed fiberglass edges and drilled holes to prevent mois-

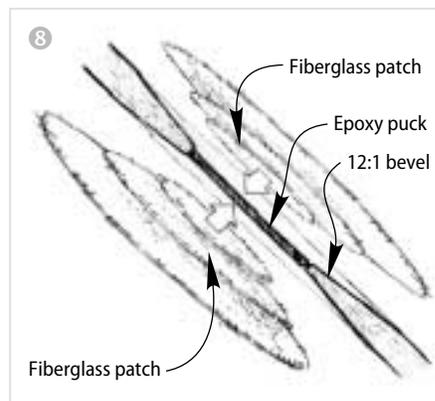
Now grind back about 1/8" to 3/16" (depending on how thick the puck is) thickness from the laminate on both sides of the hole on a 12:1 bevel. This will give the beveled area about 5" diameter. Fill the beveled area on both sides with a layered fiberglass patch and epoxy. Once the patches cure, sand them and an area larger than the patch to prep for fairing and finishing. It is especially important to remove all the antifouling paint anywhere epoxy will be applied because epoxy will not stick well to most bottom paints.
